## **Riparian Restoration of a Reach of the Turtle River Utilizing Soil Bioengineering**

By  
F. Beaver<sup>1</sup>  
M. Johnson<sup>2</sup>  
L. Kingery<sup>3</sup>  
J. Warne<sup>4</sup>  
D. Rush<sup>5</sup>

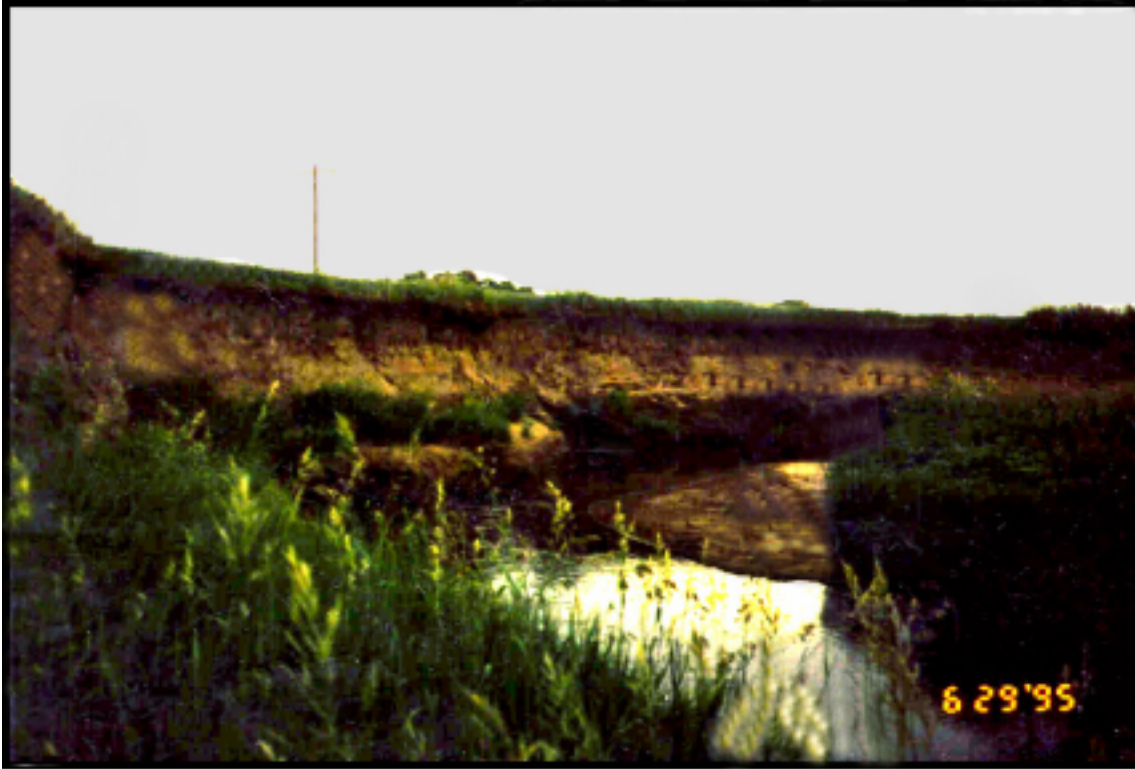
Figure 2: The site before restoration.

The area is prime farmland, and for the most part, a buffer of native bottomland hardwoods has been maintained. At this site, however, the loss of woody vegetation left the stream bank vulnerable to severe erosion. The situation was exacerbated by groundwater seeps above the base flow elevation of the river. During the period 1978 to 1995, the river migrated approximately 3.5 feet per year to the east until a fourteen foot cut bank was only 80 feet from the county road right of way. Glacial Lake Agassiz lake plain sediments consisting of silt and clay with some sand comprise the geologic setting. When dry, the sediments have sufficient shear strength to stand in vertical cut banks. However, when they are saturated, these sediments lose shear strength, and collapse readily when undercut by the current along a cut bank. Concern for the integrity of the county road grew but no action was taken because no funds were available for construction.

This paper focuses on riparian restoration and bank stabilization along a short reach of deforested river that was threatening the integrity of a county highway. The Turtle River two miles north of the junction of U.S. Highway 2 and Grand Forks County Road 2 or "as the crow flies," a mile east of Turtle River State Park in North Dakota, changes course abruptly over a distance of approximately one hundred yards from an eastwardly flowing stream to a northwardly flowing stream (Figure 1). The northwardly flowing reach closely parallels Grand Forks County Road 2. Figure 2 shows the cut bank near the highway before restoration.

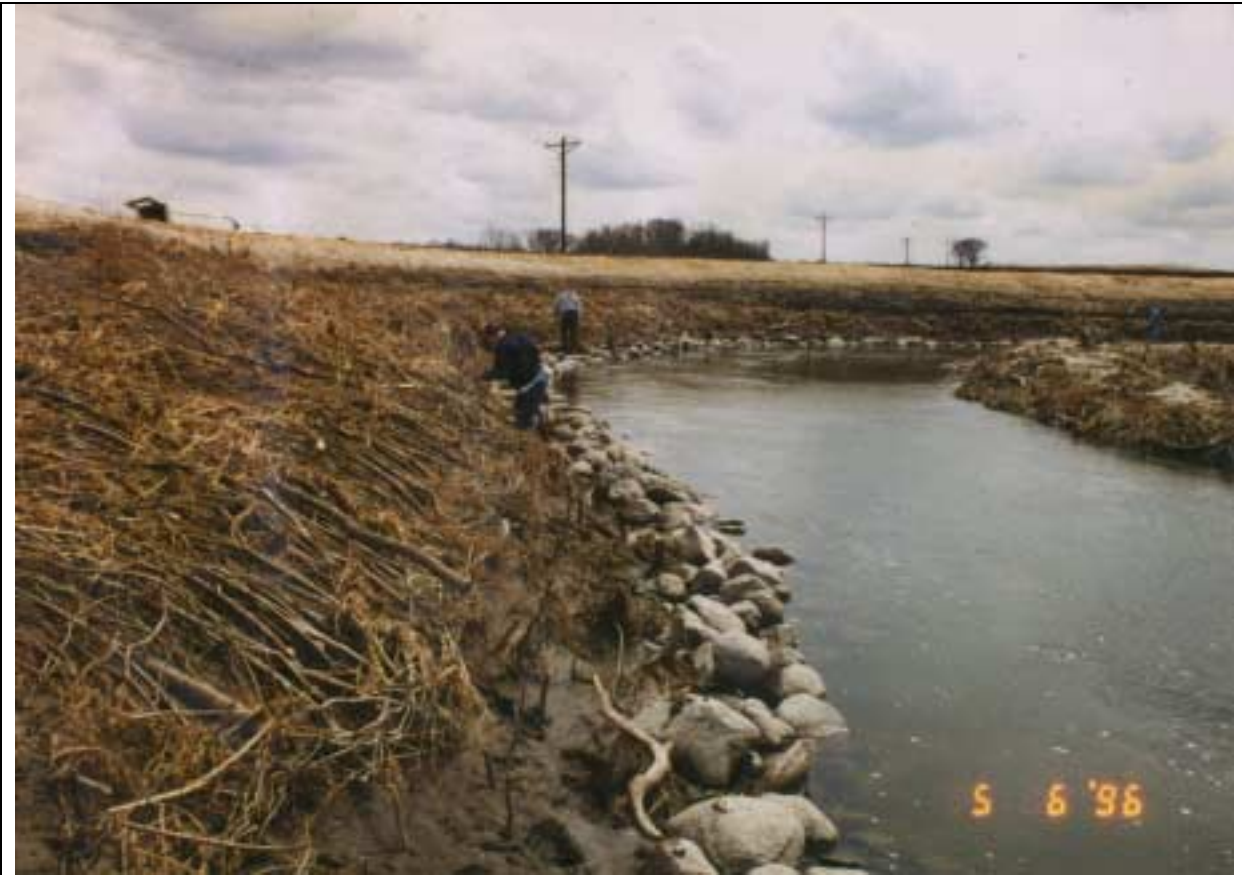
- 1) Migration of the channel appears to have stopped completely. The 1997 channel shown on figure 1 is also the channel location as of July 2001. Figure 4 is the site after restoration.

- 2) The high flows experienced in the spring of 1996 tested the site. Erosion occurred along the top of the rip-rap, uncovering and undermining the fascine. The soil was immediately replaced and subsequently washed away during another period of high flow. The site was repaired again by Americorp volunteers in early June 1996. By September 1996 the willow mattress and fascine sprouted prolifically.

- 3) With the exception of a small washout in the slope face on the downstream end, there has been no further disruption of the slope which subsequently experienced a spring flood in 1997 and a summer flood in 2000.

- 4) Several episodes of high water combined with browsing by deer and beaver stressed the newly planted seedlings, but the majority of the plants have survived and are growing.

Figure 4: The site after restoration.

Maintenance is critically important during the initial establishment. The loose fill used at the toe was susceptible to erosion, especially in the first season. The site appears to have responded well to the repair work. The use of root wads should be considered at subsequent sites. Similarly, the use of synthetic mesh may be considered in problem areas.
